# DS9400 Series

EN | Release Notes for Firmware V2.07  
Fire Alarm Control Panel

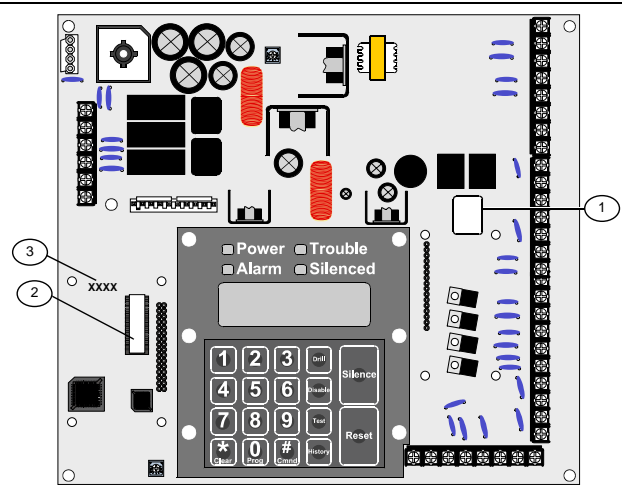
**Figure 1: Firmware Version Label and Date Code Locations**

Boards shipped before August 31, 1999 must be modified according to Technical Service Note (P/N: 42363) to ensure that the battery test runs properly. Affected boards carry a lot number of 99 or lower and a date code of 9935 or earlier. Boards shipped after August 31, 1999 with a date code higher than 9935 are unaffected. See Figure 1 on page 3 for the location of the lot number and date code.

- 1 Lot Number Label
- 2 Firmware Version Label
- 3 Date Code Stamp
